Laser Damage Testing of Molybdenum Shutter

May 1999

TARDEC Technical Report No. 13766

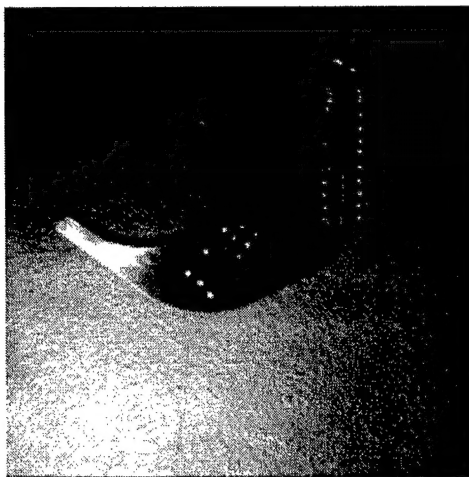
Figure 3. Molybdenum Test Sample

4.1 A summary of the laser damage test results for the Molybdenum shutter is presented in Table 1. Figure 3 shows the test sample after it had been tested. Figure 4 provides a close-up of the test sites showing a grid pattern. The circles in the figure show the sites that were not damaged. The scale shown at left of the figure is 1 millimeter/divison.

4.2 The multiple shot laser-induced damage threshold for the Molybdenum test sample was 0.19 J/cm².

6.1 We recommend that this type of Molybdenum sample not be used as a shutter for TARDEC's Continuum Powerlite Nd:YAG laser because the sample will damage under typical operating conditions.

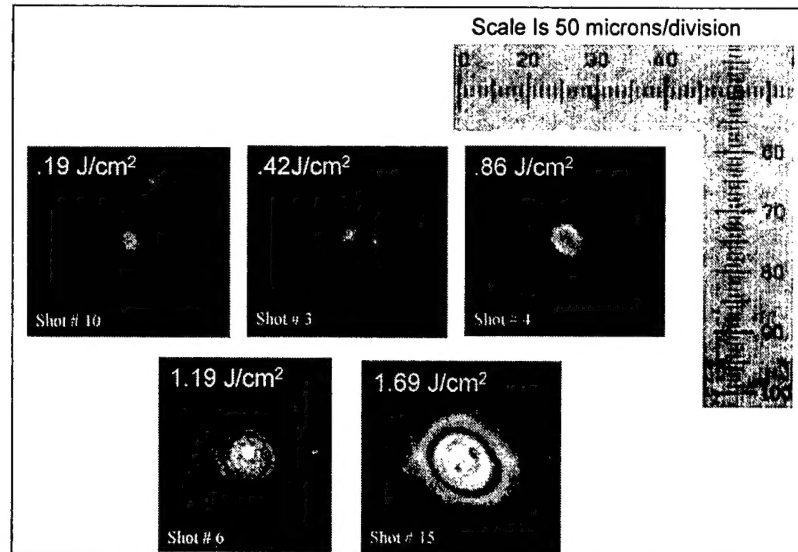
Figure 5. Damage with Increasing Fluence

4.3 While testing the Molybdenum sample we noted that the damaged area increased as the fluence increased. This is illustrated in Figure 5. We also determined that the damage spot size increase is directly related to the increase in input fluence. For example: for site 15 the fluence was 1.69 J/cm² and the area of the damage spot was 159

mm² and for site 10 the fluence was 0.19 J/cm² and the area of the damage spot was 0.0177 mm² (see Figure 6). The ratio of the two site's fluences (8.90) and damage spot areas (8.98) was nearly identical.

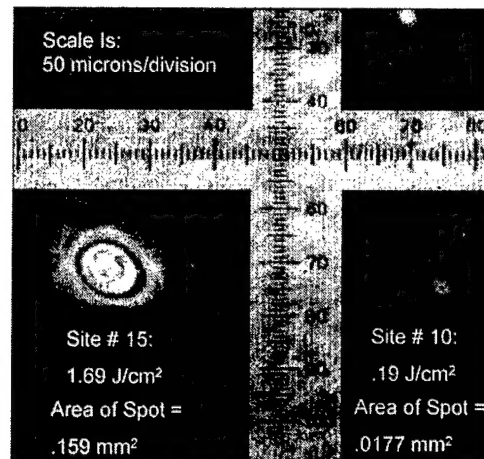
Figure 6. Comparison of Damage Spot Areas

4.4 After examining the damage sites, it was apparent that several of the damage sites had a ring or halo surrounding the primary elliptical damage site. This effect was seen for input fluences greater than or equal to 1.19 J/cm². It was postulated that this ring was caused by a laser-induced shockwave. The ring may be the result of a shock propagating out from the center of the damage site, ejecting coating material at the peak of the first crest. The dark ring may be coating left intact at the first minimum.
